Manhole Inspection Summary

Manhole # S49C__035MH

Insp Date: **5/7/08 8:31 AM**

Location Address: **2608 pulaski hwy**

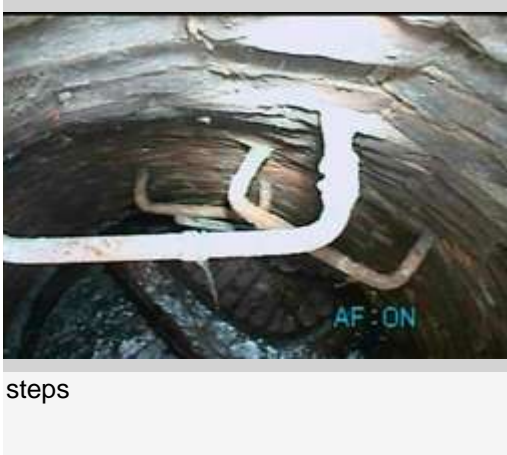
Defect 1

Count: **4** Missing: **1** ☒ **Corroded**

steps

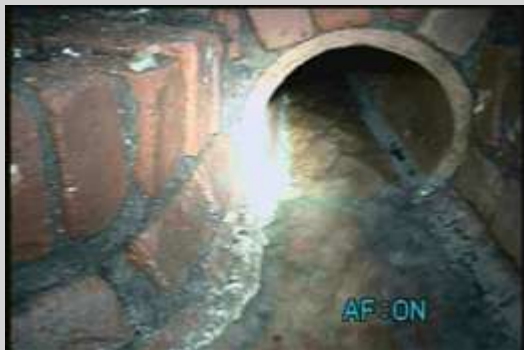
12 O'Clock Outflow

8 in. Circular Gravity Sewer
Pipe Out @ 12 O'Clock

Infiltration: **None** Pipe Seal Cond: **Unknown**

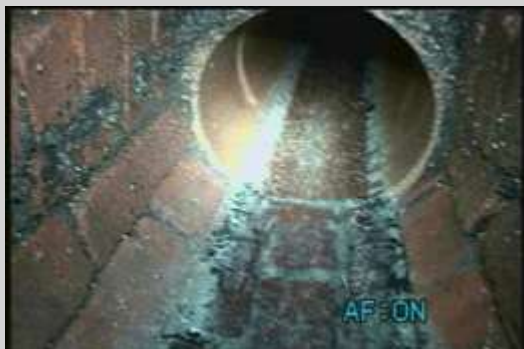
6 O'Clock Inflow

8 in. Circular Gravity Sewer
Pipe In @ 6 O'Clock

Infiltration: **None** Pipe Seal Cond: **Unknown**

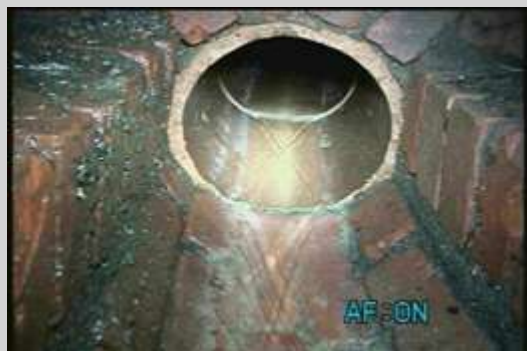
9 O'Clock Inflow

8 in. Circular Gravity Sewer
Pipe In @ 9 O'Clock

Infiltration: **None** Pipe Seal Cond: **Unknown**
